## Distribution Relationship Between Veins of Groundwater, Slope angles, and Slope Failures at a Landslide in Crystalline Schist Area

Gen FURUYA\*, Kyoji SASSA, Akira SUEMINE

### Synopsis

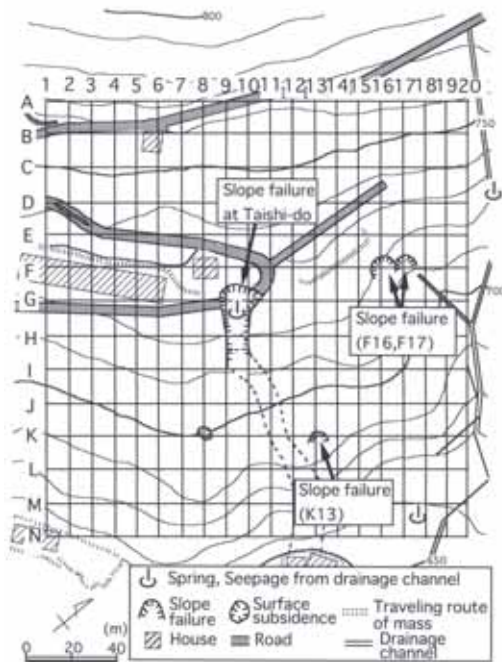
Fig. 3 Measurement net of the Taishi-do area

Fig.3 shows the topography of the Taishi-do area. The average slope angle of the Taishi-do area is  $32^\circ$ . There are four slope failures caused by the heavy rainfall at the Taishi-do area. In the largest slope failure (called slope failure at Taishi-do), the

depth of slip surface is 3m and volume is approximately 500m<sup>3</sup>(Furuya et al., 2000). For the other slope failures, the depth of slip surface is within 1-2m and volume is approximately 100m<sup>3</sup>. There are three springs at the Taishi-do area located at the bottom of the failed slope at Taishi-do, approximately 140m east side of the slope failure at Taishi-do, and approximately 140m northeast side of this slope failure. The spring of northeast side of this slope failure is seepage from the drainage channel.

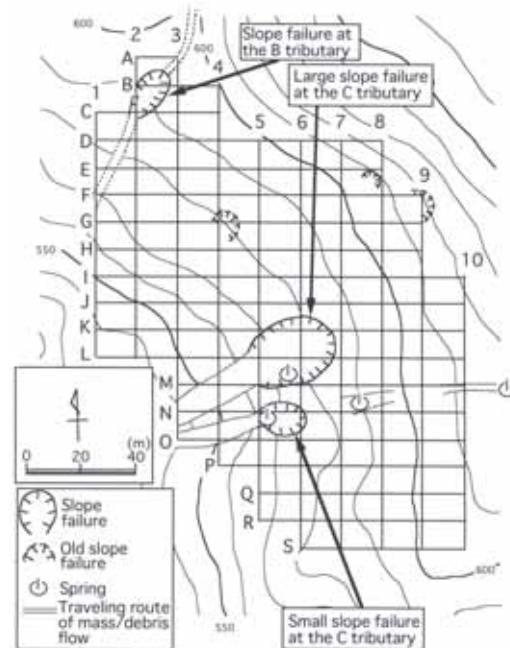
Fig. 4 Measurement net of the B, C tributaries at Tobinosu torrent

Fig.4 shows the topography of the source areas of debris flow at the B, C tributary Tobinosu torrent. The average slope angle of this area is 35° which is a bit of steeper than the Taishi-do area. In this area, there are 3 slope failures triggered debris flows due to heavy rainfall. The slope failure at the B tributary locates in torrent bed whose volume is 2500m<sup>3</sup>. At the C tributary, there is large type slope failure (called large slope failure at the C tributary) and a small slope type slope failure (called small slope failure at the C tributary), with a total volume of 3500m<sup>3</sup>(Hiramatsu et al., 1999). Depth of these slope failures is 2-3m. In addition, there is the old slope failure with a volume of hundreds located between the slope failure at the B tributary and the large slope failure at the C tributary. Also, there are some small recent and old slope failures illustrated in the northeast part of this figure. These small failures are not considered in this study because volume is very small and surface layer is thin. There are four springs at this area, located in the C tributary. One is on the scarp of the large slope failure at the C tributary. The others are located on the scarp of the small slope failure and at the upper slope of this slope failure.

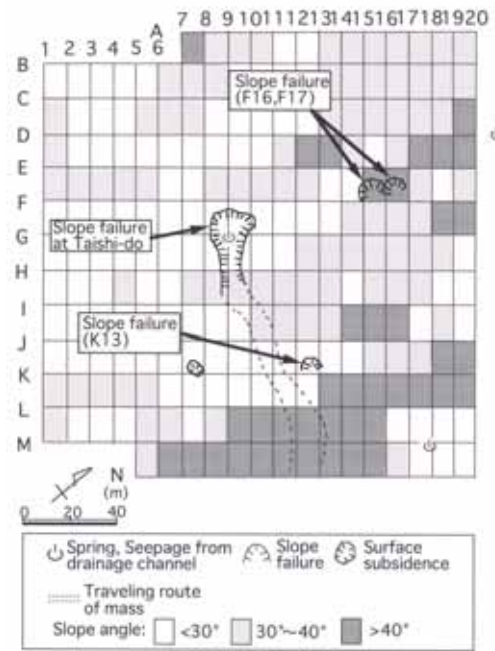
Fig. 5 Distribution of maximum slope angle at the Taishi-do area

Fig.5 shows a distribution of maximum slope angle at the Taishi-do area. In this figure, the slope angle is divided into three categories: less than  $30^\circ$ , more than  $30^\circ$  to less than  $40^\circ$ , and more than  $40^\circ$ . Although the slope greater than  $30^\circ$  distribute almost uniformly across the measurement net, the east part of the measurement net shows a higher concentration. The slopes greater than  $40^\circ$  are distributed mostly at southeast and a part of northeast. The slope failures at F16, F17 and K13 are located in the area of gradients greater than  $40^\circ$ . On the other hand, the slope failure at Taishi-do fall within the category of gentle slopes less than  $30^\circ$ .

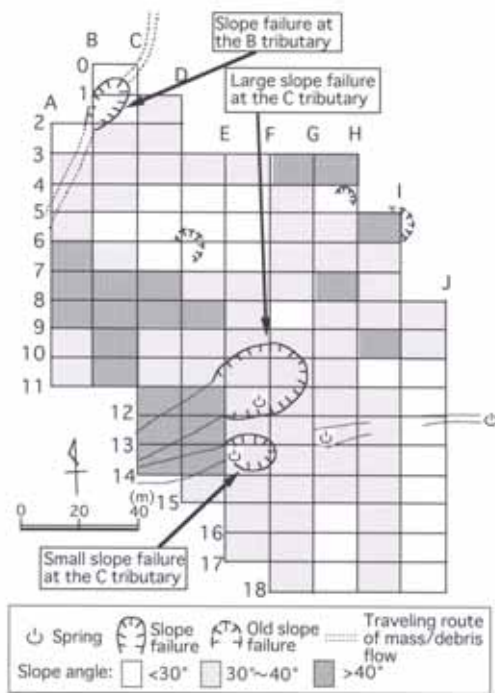
Fig. 6 Distribution of maximum slope angle at the B, C tributaries at Tobinosu torrent

Fig.6 shows a distribution of the maximum slope angle at the area of B, C tributaries in Tobinosu torrent. The classification of slope angles is the same as in Fig.5. In this area, the slopes less than  $30^\circ$  are

concentrated at southeast and northwest. In addition the slopes greater than  $40^\circ$  are distributed at northeast and southwest in the measurement net. These parts are nearby the thin part of surface layer mentioned above. The large and small slope failures locate within the area with slopes greater than  $30^\circ$ . However, the slope failure at the B tributary and old slope failure locate on gentle slope less than  $30^\circ$ , which is the same as the case of the Taishi-do area. Then, we estimate stability of each grid at these areas by using the slope angle in Fig. 5 and Fig. 6 under a formula (1).

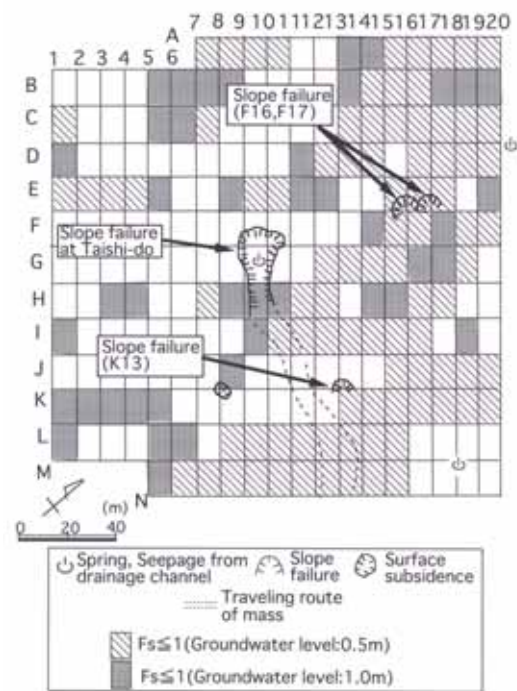
Fig. 7 Distribution of safety factors at the Taishi-do area

Fig. 7 shows the result in the case when pore water pressure value is equivalent to 0.5m of the groundwater level from slip surface and 1.0m (extreme condition) from this. In this figure, the slopes with  $F_s \leq 1$  for the water level at 0.5m occupy approximately 40 percent of the measurement net. Furthermore, the slopes showing  $F_s \leq 1$  for the water level at 1.0m occupy approximately 60 percent at that in the Taishi-do area. Although the members of potential slope failures estimated by calculation are significantly greater than the actual member of failures, three slope failures where are F16, F17 and K13 located in the area with  $F_s \leq 1$  for the water level at 1m. The slope failure at Taishi-do locates in  $F_s > 1$ , in other ward, locates in stable slope under each pore water pressure condition against to other slope failures.

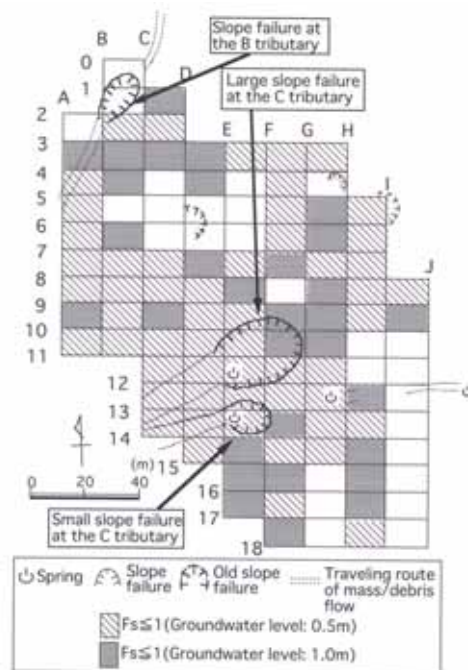
Fig. 8 Distribution of safety factors at the B, C tributaries at Tobinosu torrent

Fig. 8 shows the result of stability analysis under same pore water condition as in Fig. 7. The case of the B, C tributaries in the Tobinosu area is that the slopes with  $F_s \leq 1$  for the water level at 0.5m occupies approximately half of the area of the measurement

net, and for a water level at 1.0m occupies approximately 80 percent of the measurement net. The large and small slope failures at the C tributary locate in the area of  $F_s \leq 1$  for the water level at 1m. However, the slope failure at the B tributary and the old slope failure around D6 measurement point occurred within the area of  $F_s > 1$ , which is similar

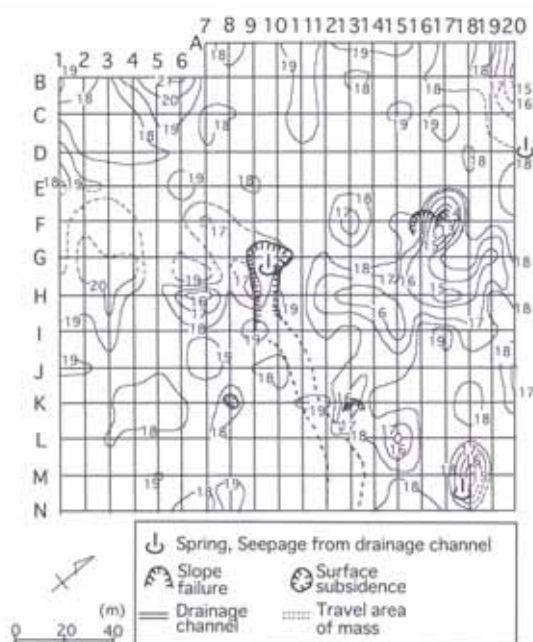
Fig. 9 Isothermal diagram at the Taishi-do area

Fig.9 shows the isothermal diagram of correction values from 12 to 22°C by 1°C at the Taishi-do area. Maximum ground temperature is 21.0°C (B6), minimum ground temperature is 12.3°C (F17), and average ground temperature is 18.2°C within this area. In this figure, the eastern part of the measurement net shows an underground temperature below the average. On the other hand, the underground temperatures in western part are higher than the average. There are three large zones with temperatures less than 18°C (i.e. slightly less than average value) at the Taishi-do area: 1) From C1 and C3 to G9 (E6 is a bit high value) which is approximately the direction from east to west, 2) From E17 to N15 through L12 direction which is approximately oriented on southeast northwest, and 3) From A17 and A19 to D20 located at north part of the measurement net. All slope failures at the Taishi-do area locate in the zone of temperatures less than 18 °C. The temperature of the slope failure at Taishi-do and K13 are a little lower than average underground temperature. However, the slope

failures at F16 and F17 locate within the low temperature zone. The slope failure at F17 is also in the zone of the minimum underground temperature. This is a characteristic fact in the Taishi-do area.

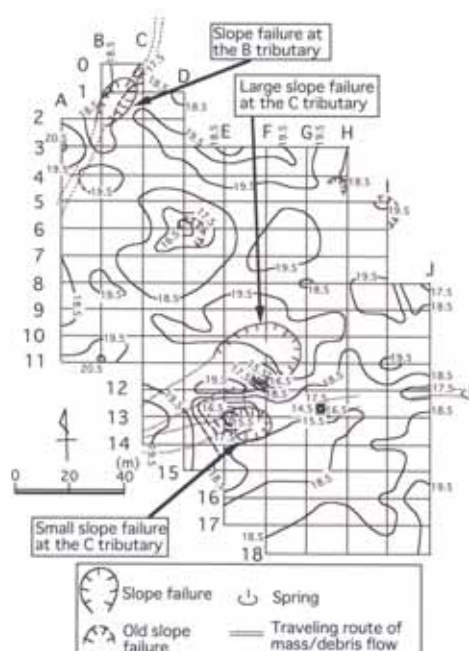
Fig. 10 Isothermal diagram at the B, C tributaries in Tobinosu torrent

Fig.10 shows the isothermal diagram of correction values of the one-meter depth underground temperature survey and local temperature around springs at the B, C tributary in Tobinosu torrent from 15.5 to 20.5°C by 1°C. Maximum ground temperature is 20.6°C (A3), minimum ground temperature is 15.1°C (E13), and average ground temperature is 18.9°C at this area. Groundwater temperature at springs in the B, C tributaries at the Tobinosu torrent are lower than minimum measurement value. The temperature at upper J12 is 12.7 °C; in point F12 (the large slope failure at the C tributary) is 13.9°C; at G12-13 is 14.1°C, and at E13 (the small slope failure at the C tributary) is 13.5°C.

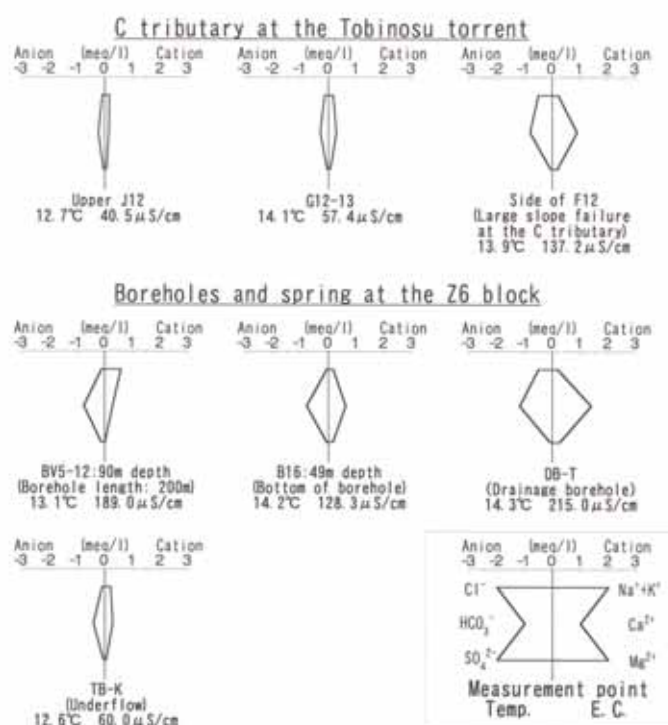
Fig. 11 Results of water quality analysis

Fig. 11 gives as the results of measured groundwater temperature, electric conductivity and hexa diagram of the ion concentrations at some springs of the C tributary at the Tobinosu torrent, as well as at the boreholes and underflow in the Z6 block during the one-meter depth underground temperature survey. In this figure, the measured groundwater temperature at the springs in the C tributary Tobinosu torrent are approximately the same as the values measured in all points of Z6 block (i.e., 12 to 14°C). When attention is paid to the results of electric conductivity, the springs at the C tributary have the values in two diagrams (Upper J12 and G12-13) the same as the results of boreholes in the Z6 block, and the value in third diagram (Side of F12: Large slope failure at the C tributary) the same as

the data of TB-K (Underflow) at the Z6 block. From the results of hexa diagram, the Upper J12 and G12-13 don't show a clear water quality pattern. This is similar with the analysis results at TB-K at the Z6 block. On the other hand, the Side of F12 has clear Ca-HCO<sub>3</sub> water quality type, which is the same as in points B16 and the DB-T of the Z6 block. This water quality type has the same tendency as the results provided by Yoshioka et al., (1973) who carried out investigation along the Iya River. The water quality at BV5-12 is Na, K-HCO<sub>3</sub> type, which is different from the water quality at another boreholes in the Z6 block. The reason for this difference may be the fact that the geology of the upper part of slope is different from the geology of middle part of slope at the Z6 block shown in Fig.2.

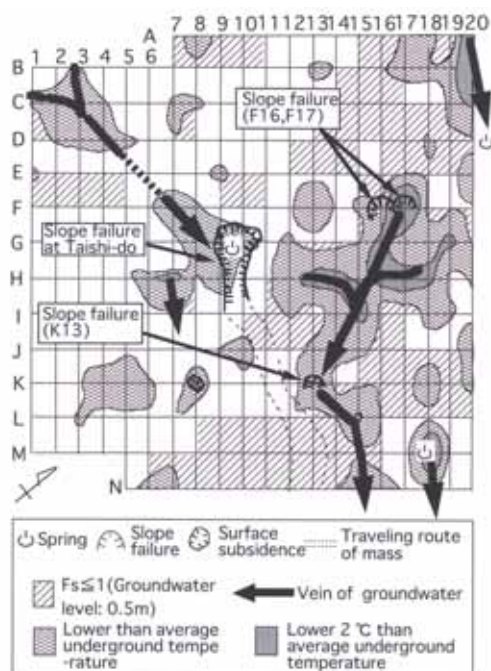
Fig.12 Distribution of veins of groundwater, safety factors, and slope failures at the Taishi-do area

into lower than average underground temperature zones (18.2°C) and zones with temperatures lower by 2°C than average underground temperature. There are five veins of groundwater at the Taishi-do area (Furuya et al., 2004): Zone 1 from C1 and C3 to G9, Zone 2 from E17 to N15 through K13, Zone 3 from A17 and A19 to D20, Zone 4 area around H7, and Zone 5 area around M18. Zone 1 and 2 are large veins of groundwater for the measurement net, however, the groundwater type is different in these two veins represent. In zone 1 the lowest value is 16.9°C at point H9 (Furuya et al., 2000) and the spring in slope failure at Taishi-do is 17.8°C as shown in Table 1. Thus the temperature in this vein is not so low compared with the average value, and is 4 to 5°C higher than the boreholes at the Z6 block. On the other hand, the lowest ground temperature at a depth of 1m in zone 2 is 12.3°C at point F17. This is also the lowest value in the measurement net, and is approximately equal to the groundwater temperature at the boreholes of Z6 block. In addition, when the ground temperature of F17 was measured, groundwater was oozing through the measurement hole of this measurement point (Furuya et al., 2000). Therefore, it may be stated that the vein of groundwater in zone 1 is of shallow origin, while the vein of groundwater in zone 2 originates groundwater from deep layers. The other veins of groundwater in the surveying area aren't widely distributed being rather than local. However, they have remarkable low underground temperature part. This may be attributed to the small scale of these veins rising from deep layers.

The slope failure at associated with  $F_s > 1$  in Fig. 5 (gentle slope less than 30°) is actually locates on the vein of groundwater corresponding to zone 1. Furthermore, the results of stability analysis indicate a stable slope even for a pore water pressure calculated from a groundwater level at 1.0m above the slip surface. Hence, it may be concluded that the slope failure at Taishi-do was caused by the increase in pore water pressure due to concentrated groundwater along the vein of groundwater in zone 1 during the heavy rainfall. The slope failures at F16 and F17 locate on and nearby the beginning of the vein of groundwater in zone 2. Recall that underground temperature at a 1m depth in point F17 is lowest, and is approximately equal to the groundwater temperature in the boreholes at the Z6 block. Thus we can consider as the outlet of groundwater originating from the deep layers. In these circumstances the occurrence of these slope failures could be related to the existence of a vein of groundwater originating from the deep layers. This vein of groundwater is flowing like underflow in subsurface toward K13. The vein of groundwater in zone 2 could also be responsible of the slope failure at K13.

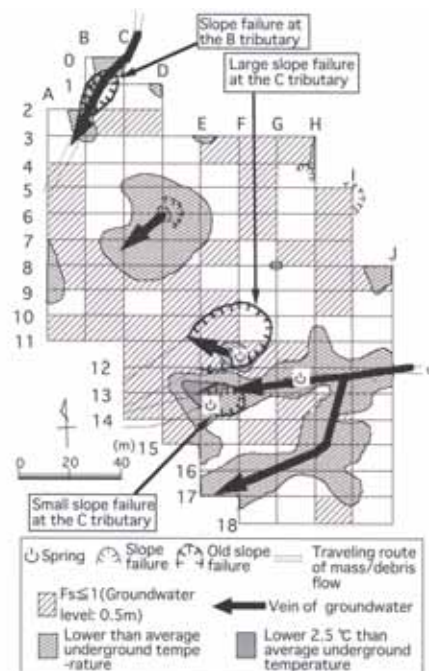
Fig.13 Distribution of veins of groundwater, safety factors, and slope failures at the B, C tributaries in Tobinosu torrent

Fig. 13 shows the coupled distributions of the low underground temperature zones, veins of groundwater, the real slope failures and the slope with  $F_s \leq 1$  at the B, C tributaries, Tobinosu torrent. The assumed water level for slope stability calculation was at 50cm

above the slip surface. This figure shows the lower than average underground temperature zones (i.e., 18.2°C) and zones with temperatures lower by 2.5°C than average underground temperature. The veins of groundwater are as follows: zone 1 along the B tributary (C0 to B3); zone 2 large slope failure at the C tributary; zone 3 upper slope of J12 to the small failure at the C tributary with branch vein at I11 to F17, and zone 4 the area within a range of approximate 40m x 40m around D6 (Furuya et al., 2001). The vein of groundwater in zone 3 is underflow type because the springs in the upper slope of the small slope failure at the C tributary are distributed over a line and these springs show a concentration of dissolved ions (electric conductivity) similar with the TB-K at the Z6 block (see the results of water quality analysis in Fig. 11). The branch stream of this vein of groundwater starting from I12 may also be of underflow type. No spring exists at the B tributary. However, it is believed that the vein of groundwater along the B tributary is flowing under the torrent bed of this tributary because the zone of low underground temperature is along the torrent bed. Hence, it can be concluded that the underflow type is the same as for TB-K at Z6 block. The low temperature distribution disappears around B3 suggesting that the vein of groundwater infiltrates into the deep zone of the torrent bed. The large slope failure at the C tributary has a spring on the lateral side at F12, which scale of vein is very small. The water quality type of this spring differs from that of the vein of groundwater in zone 3 which flows neighboring the large slope failure shown in Fig. 11. In the Zentoku area, many cracks were found on outcrops of bedrock during field investigations, as well as in the rock mass during the construction of a drainage well. Hence, the vein of groundwater in zone 2 appears to be of fissure water type. This vein of groundwater is presumed that raising steep angle from deep layers by the calculation results based on thermal conductivity type differential equation (Furuya et al., 2001). The water quality of this vein and the dissolved ion concentration are the same as at locations B14 and DB-T in Z6 block. Therefore, the vein of groundwater zone 2 is discharging from the deep layers equivalent to the slip surface at Z6 block. There is no spring around D6. However, it is believed that the deep layer of groundwater is rising nearby surface because the zone of underground temperatures lower by 2.5°C than the average is located around D6.

There are three slope failures generating debris flows in the analyzed measurement net. The common feature in these slope failures is that they occurred in the zones of low underground temperature. Among these, the slope failure at the B tributary and the small slope failure at the C tributary are related to the underflow type vein of groundwater. On the other

hand, the large slope failure at the C tributary is related to the fissure water type vein. However, it is presumed that this slope failure rather develops retrogressively towards the upper slope instead of occurring at once. There is an old slope failure at D6 that could have been caused by water rising from fissures. This study demonstrated that by coupling the results of stability analysis with the distribution of veins of groundwater within the analyzed domain, it is possible to narrow the regions associated with a high potential of slope failure.

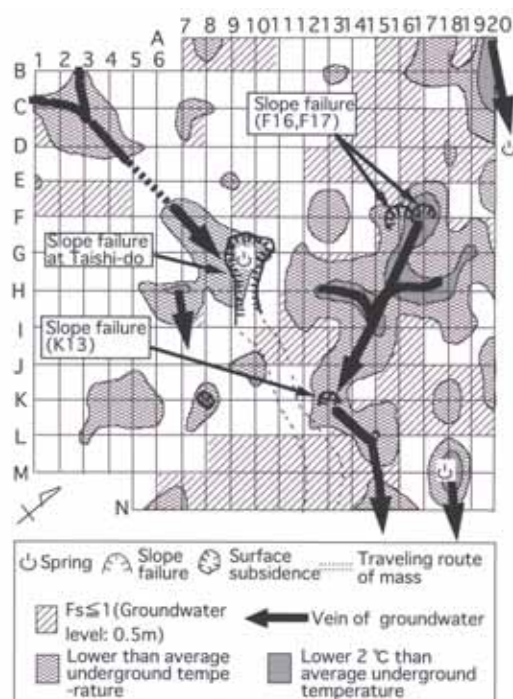
図 大師堂周辺における崩壊発生箇所、流動地下水脈および安全率1以下の分布

これらの調査対象地域の平均傾斜角は $32 \sim 34^\circ$ である。斜面崩壊は従来から指摘されている遷移点（遷急点、遷緩点）周辺で発生しているが、図に示すように、すべり面上の間

隙水圧が同条件のもとで計算した結果において他の箇所（セル）よりも安定性が高いと評価される緩傾斜（ $20 \sim 27^\circ$ ）の箇所でも発生している。流動地下水脈の分布に着目すると、調査対象地域では流動地下水の分布の有無による斜面傾斜角の違いはほとんど無い。斜面崩壊は土層深が著しく薄い箇所を除いて地下水脈の経路付近や斜面内部の地下水が地表面（付近）に流出する箇所が発生する傾向が高い。これは地下水が集中し易い箇所では斜面崩壊が発生し易いことを示唆する。なお、調査対象地域における斜面内部から流出する地下水は、水質調査結果よりすべり面相当深度のものであった。以上より、結晶片岩の地すべり地で豪雨時に発生する斜面崩壊の危険度を評価する際には斜面傾斜角に着目した評価だけでは不十分であり、現地の流動地下水の情報も併用する必要があると考えられる。
